PROGRESS REPORT NO. 35

15 SEPTEMBER 1953 to 15 DECEMBER 1953

RTV-N-12a VIKING

Engineering Report No. 6164

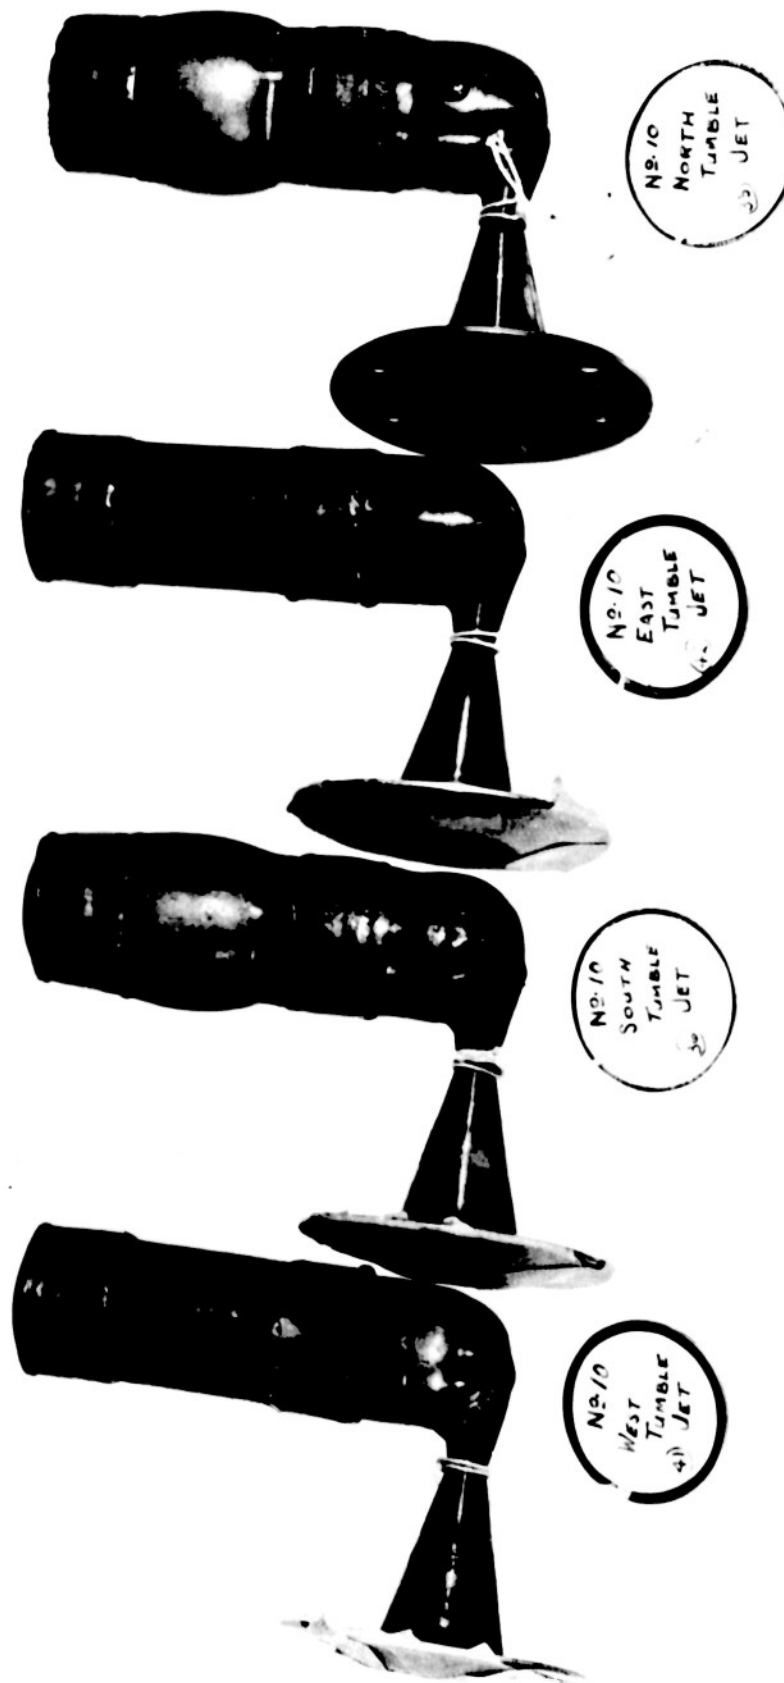
All of the  $H_2O_2$  motors which had been installed on Viking 10 at the time of the aborted flight firing were returned to GLM with the rocket. These were subsequently removed and subjected to a functional test. Performance of the roll system motors was acceptable; however, when the pitch/yaw units were operated, a malfunction in the form of high pressure surges was encountered. This anomaly resulted in damage of varying degrees to all four motors. In the case of motor No. 35, the head of the unit actually ruptured (Fig. 1). The pitch/yaw motors which are located in the tail section of the rocket apparently had sustained critical fire and water damage when the tail section of the rocket exploded and burned during a scheduled flight operation on 30 June 1953 (GLM ER 6001). This was evidenced by the large quantities of oxidization found on the catalyst screen ends, when the motors were later opened.

Fig. 1. Hydrogen Peroxide Motors from  
Viking No. 10 Damaged During Retest
